MUNICIPAL LANDFILL AUDIT REPORT

2021

LAMBERT DE KLERK

Manager: Environmental Affairs

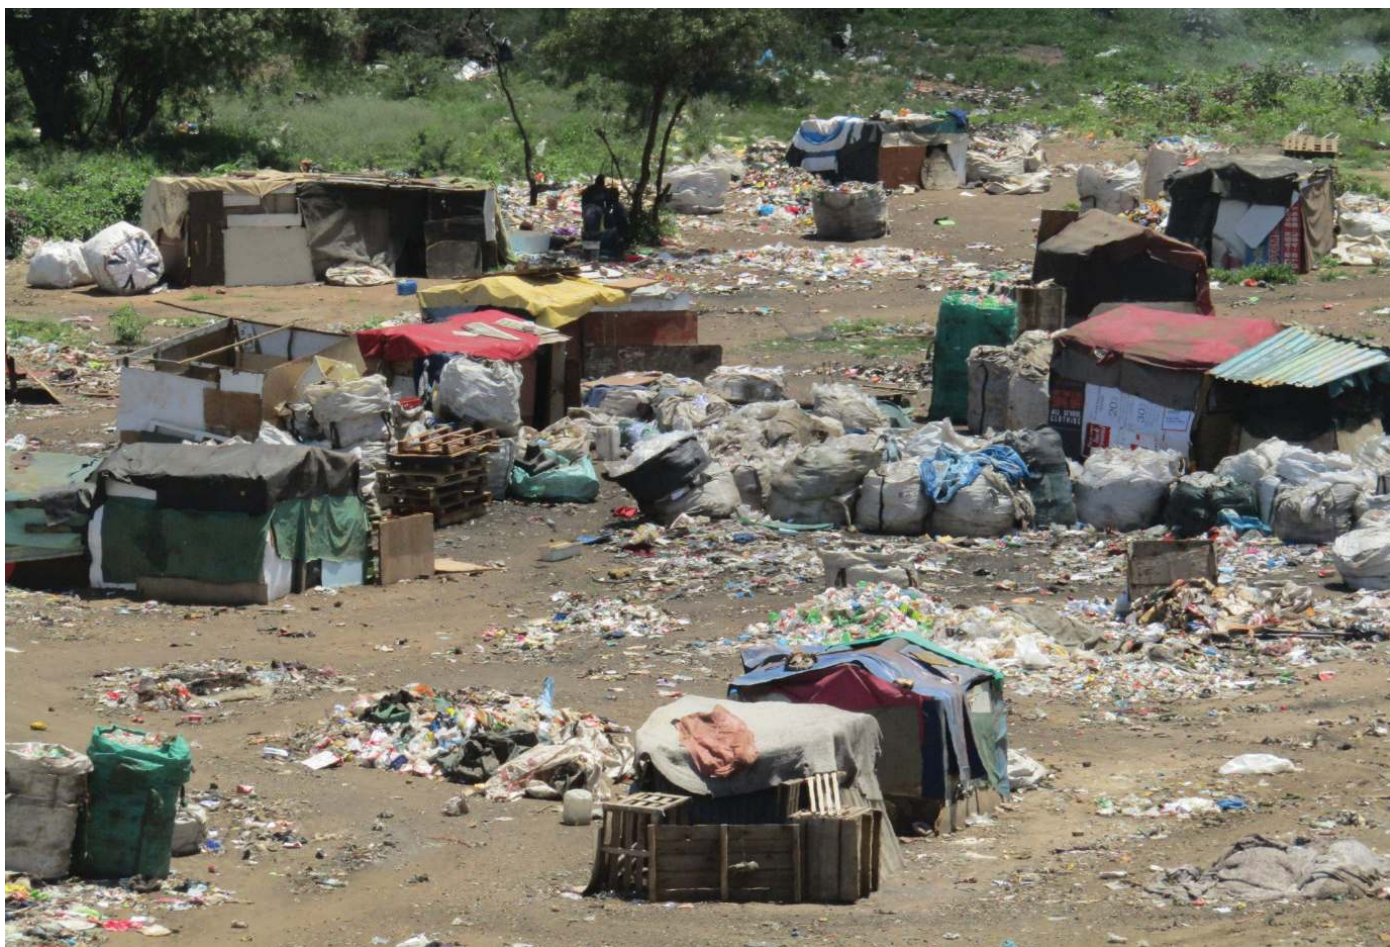
Shacks in which people live on the Klerksdorp landfill site in the North West

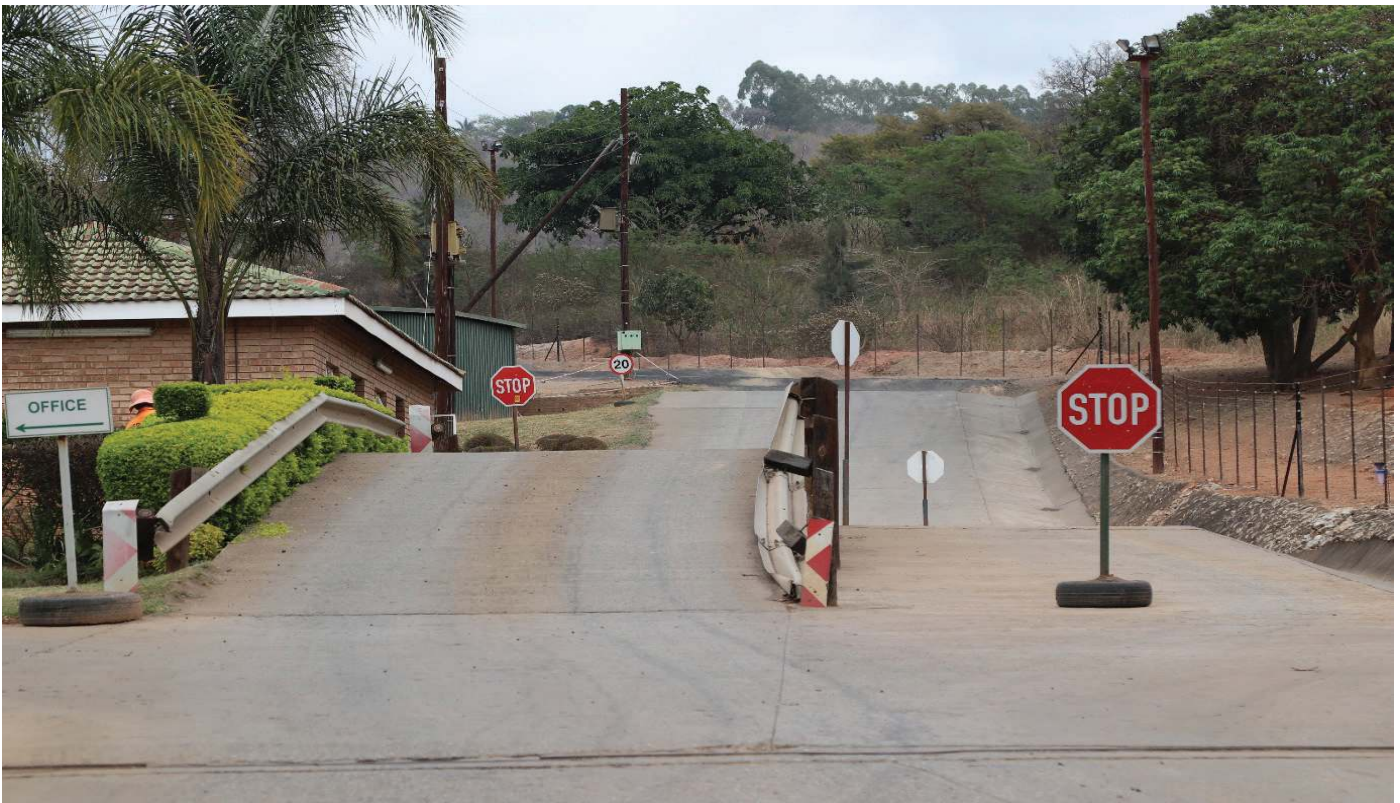
An impeccable landfill site in Tzaneen, with an operative weighbridge, fence and complete infrastructure

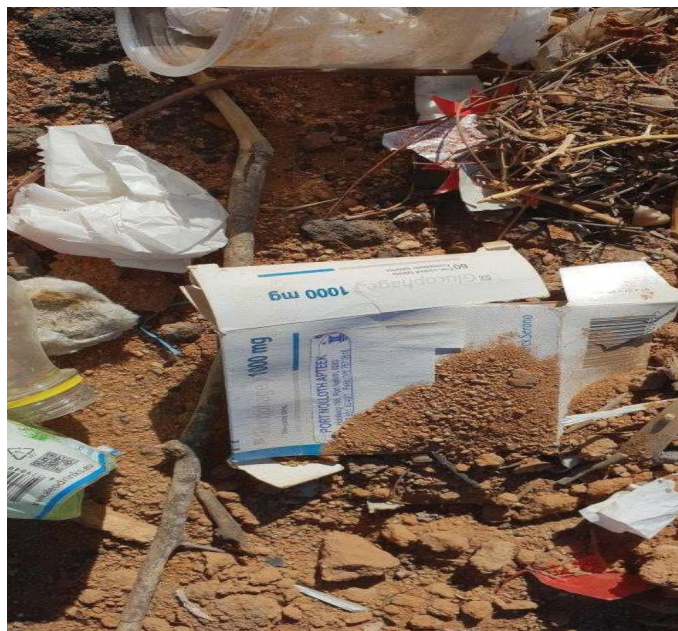
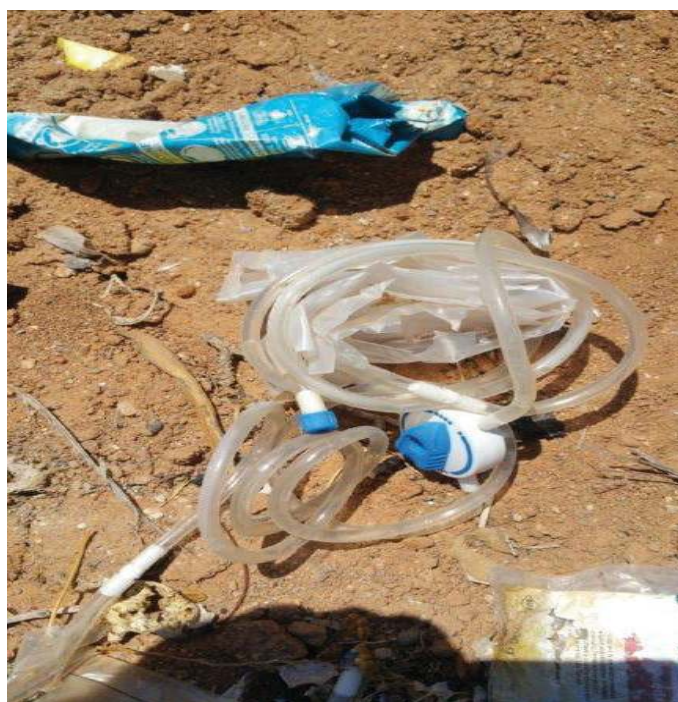
Hazardous medical waste dumped at the general Springbok landfill site in the Northern Cape.

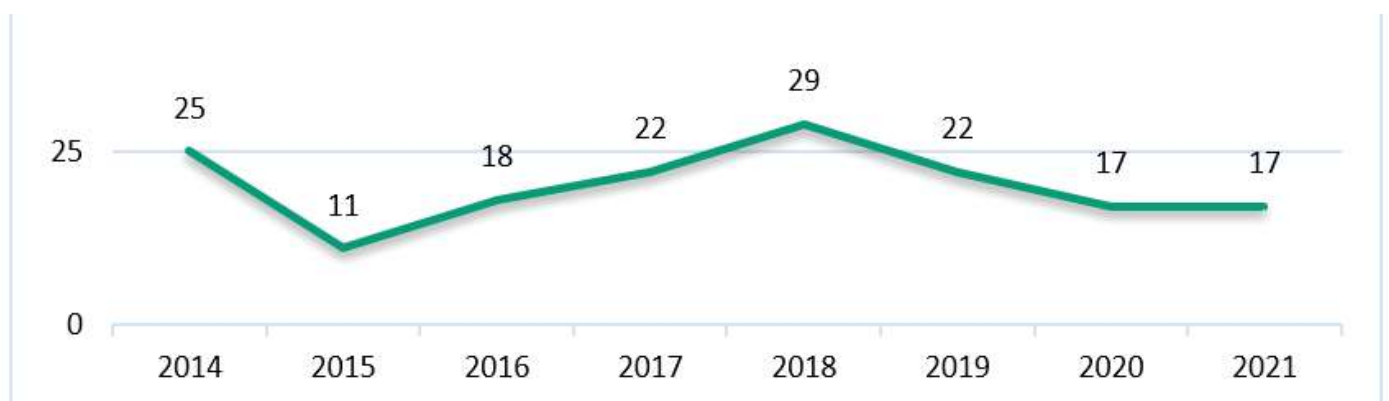
Figure 6: Average annual national compliance score (in percentages) for the period 2014–2020

The percentage of compliance at national level for the period 2014–2021 is reflected in figure 6 below.

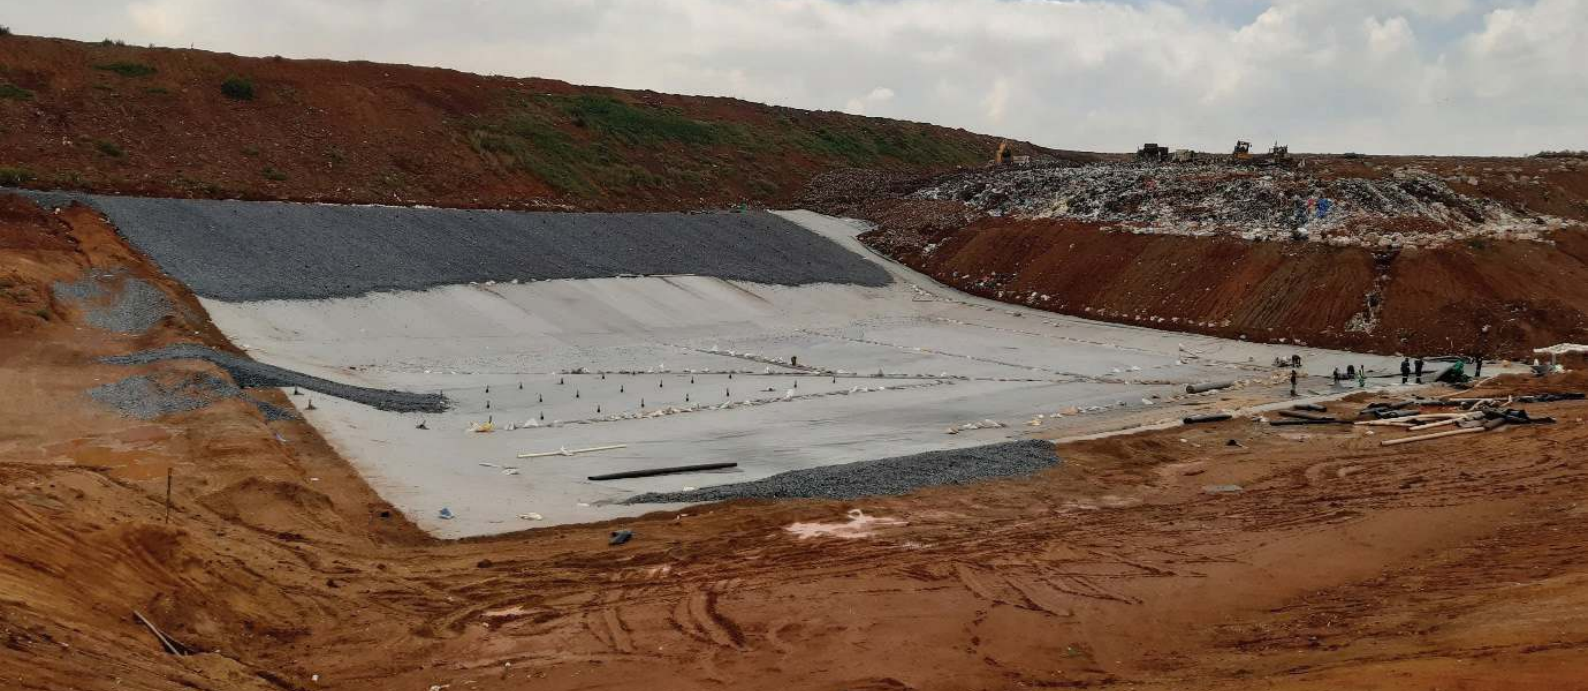
The Waste Group Class B liner being completed at the Mooiplaas landfill site in Centurion, Gauteng

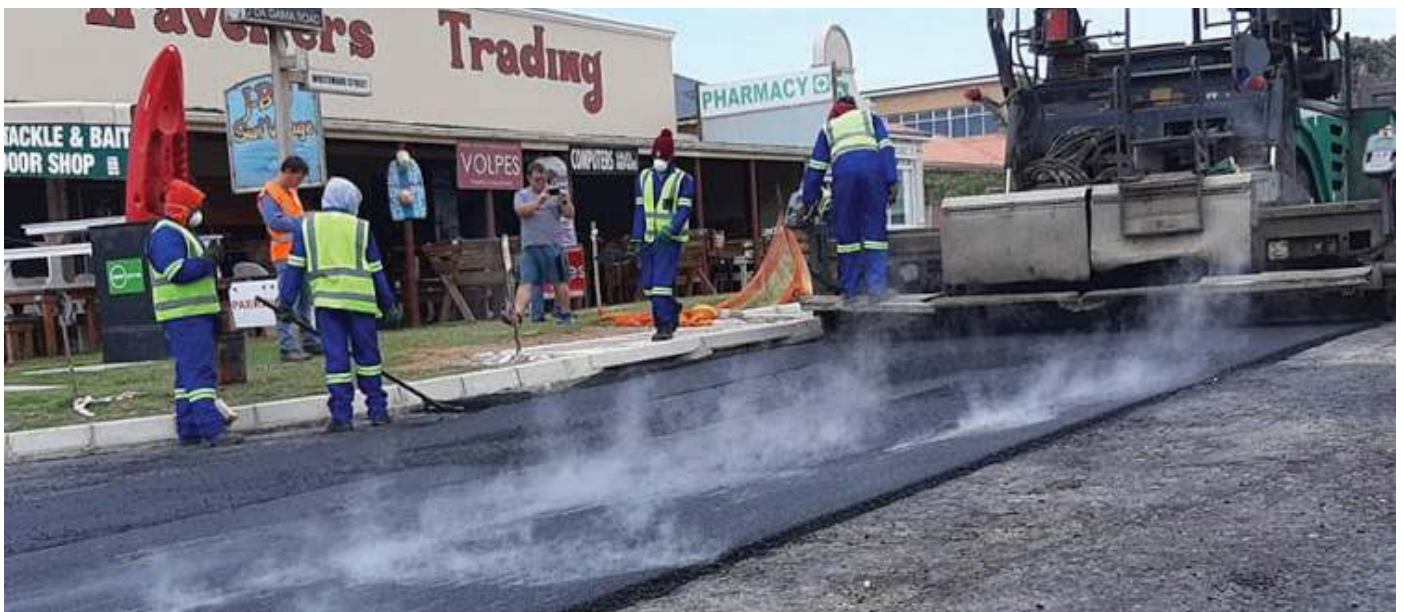
A street in Jeffreys Bay is repaired by making use of plastic waste
